F-4 BERYLLIUM RUDDERS

**A Précis of the Design, Fabrication,
Ground and Flight Test Demonstrations**

TECHNICAL REPORT AFFDL-TR-74-140

FINAL REPORT FOR PERIOD JUNE 1965 - AUGUST 1971

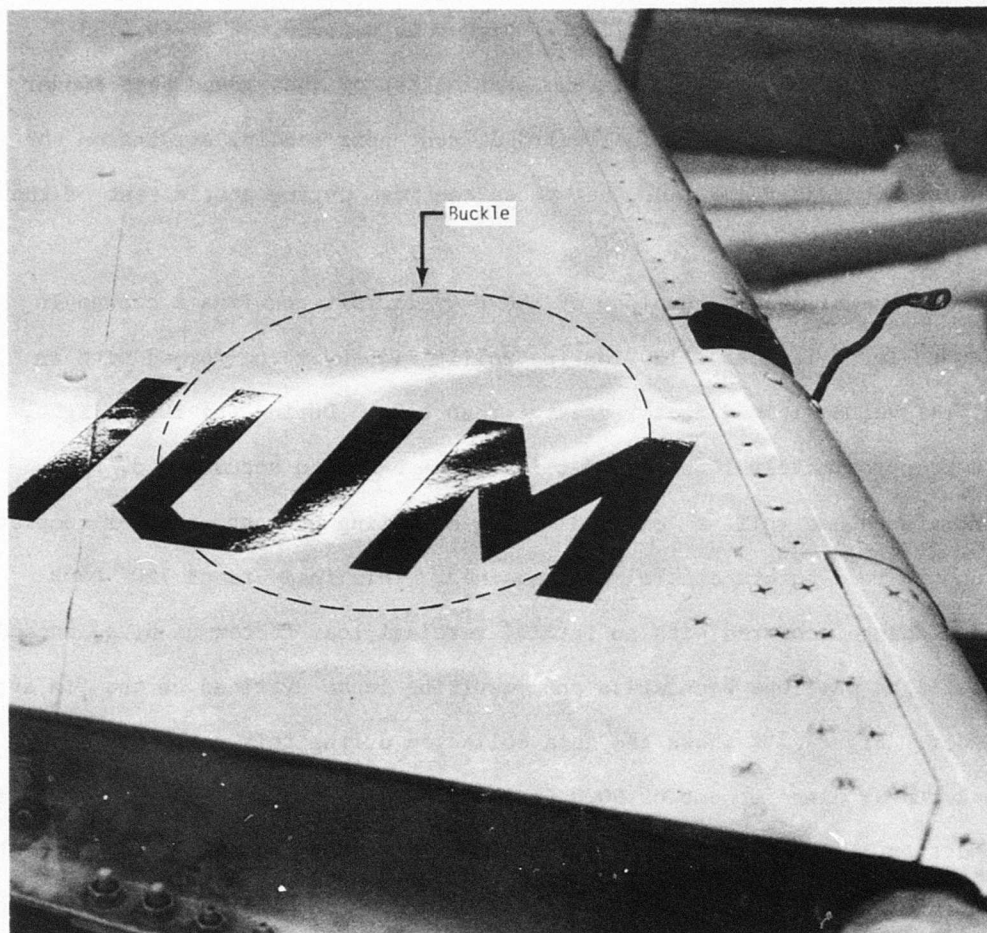
Figure 163 - Permanent Buckle in Rudder Torque Box Skin
